Rain can damage rotor blades

Test stand facilitates the simulation and analysis of the influence of weather, climate and production faults

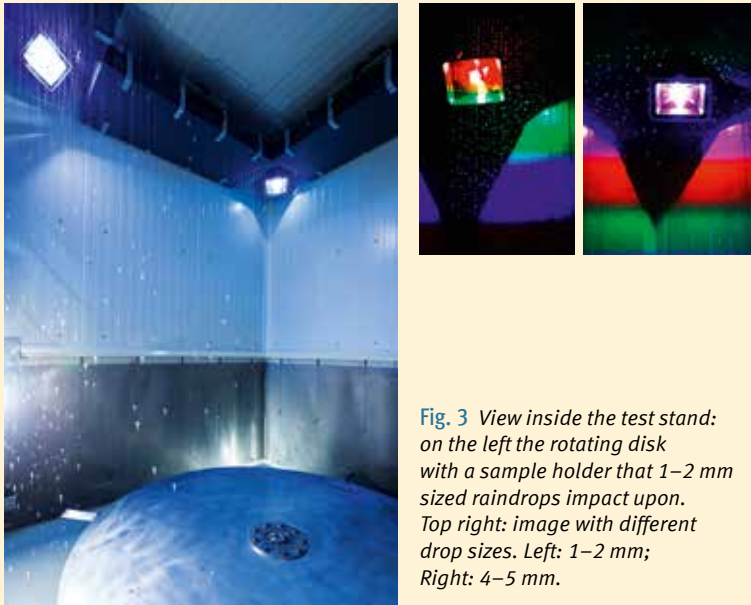
Fig. 3 View inside the test stand: on the left the rotating disk with a sample holder that 1–2 mm sized raindrops impact upon. Top right: image with different drop sizes. Left: 1–2 mm; Right: 4–5 mm.

The test stand can vary the quantity of rain between 6 and 24 l/min and the drop size between 1 and 5 mm (Fig. 3). The samples pass through a rain area of 2 m². A preliminary investigation observed the drop forms and quantities in practice and analysed and compared them with those generated in the test stand.
