Building refurbishment – Student residence hall

New and old residence hall complex in Wuppertal, Germany

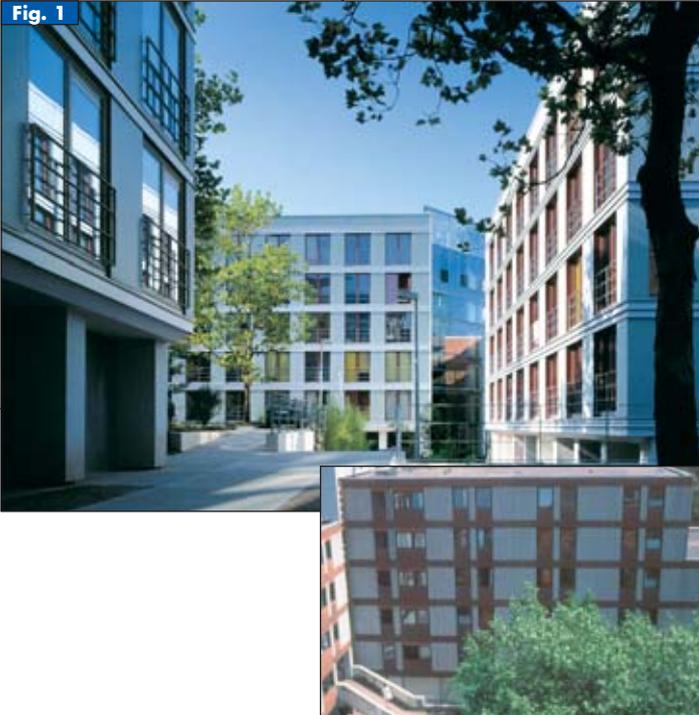
Fig. 3: Floor plan of the residence hall before and after refurbishment

During the refurbishment, the dilapidated facade, consisting of non-load-bearing slabs hanging in front of the building's shell, was removed. Only the apartments' load-bearing structure was retained. Grouped accommodation, encompassing 32 persons, has largely given way to individual apartments, each with a shower and kitchenette. The space which this requires is made by means of an extension of the building shell's room depth by approximately 2 m (fig. 3). Thus, the new hall of residence is more compact than the old structure. At the same time, the forebuilding becomes the building's reinforcing structure. The staircase or core area was removed from the middle of the building. Thus, two separate buildings are the result. The single-glazed staircase and its adjoining rooms are situated outside the thermal envelope. This enables a greater reduction of energy consumption. The structural alterations implemented in the 1st construction stage (CS) were execu-
